Ground Water Investigation Program (GWIP)
WPIC update September 14, 2011
Presented by John Wheaton, MBMG

Lower Beaverhead Valley Study

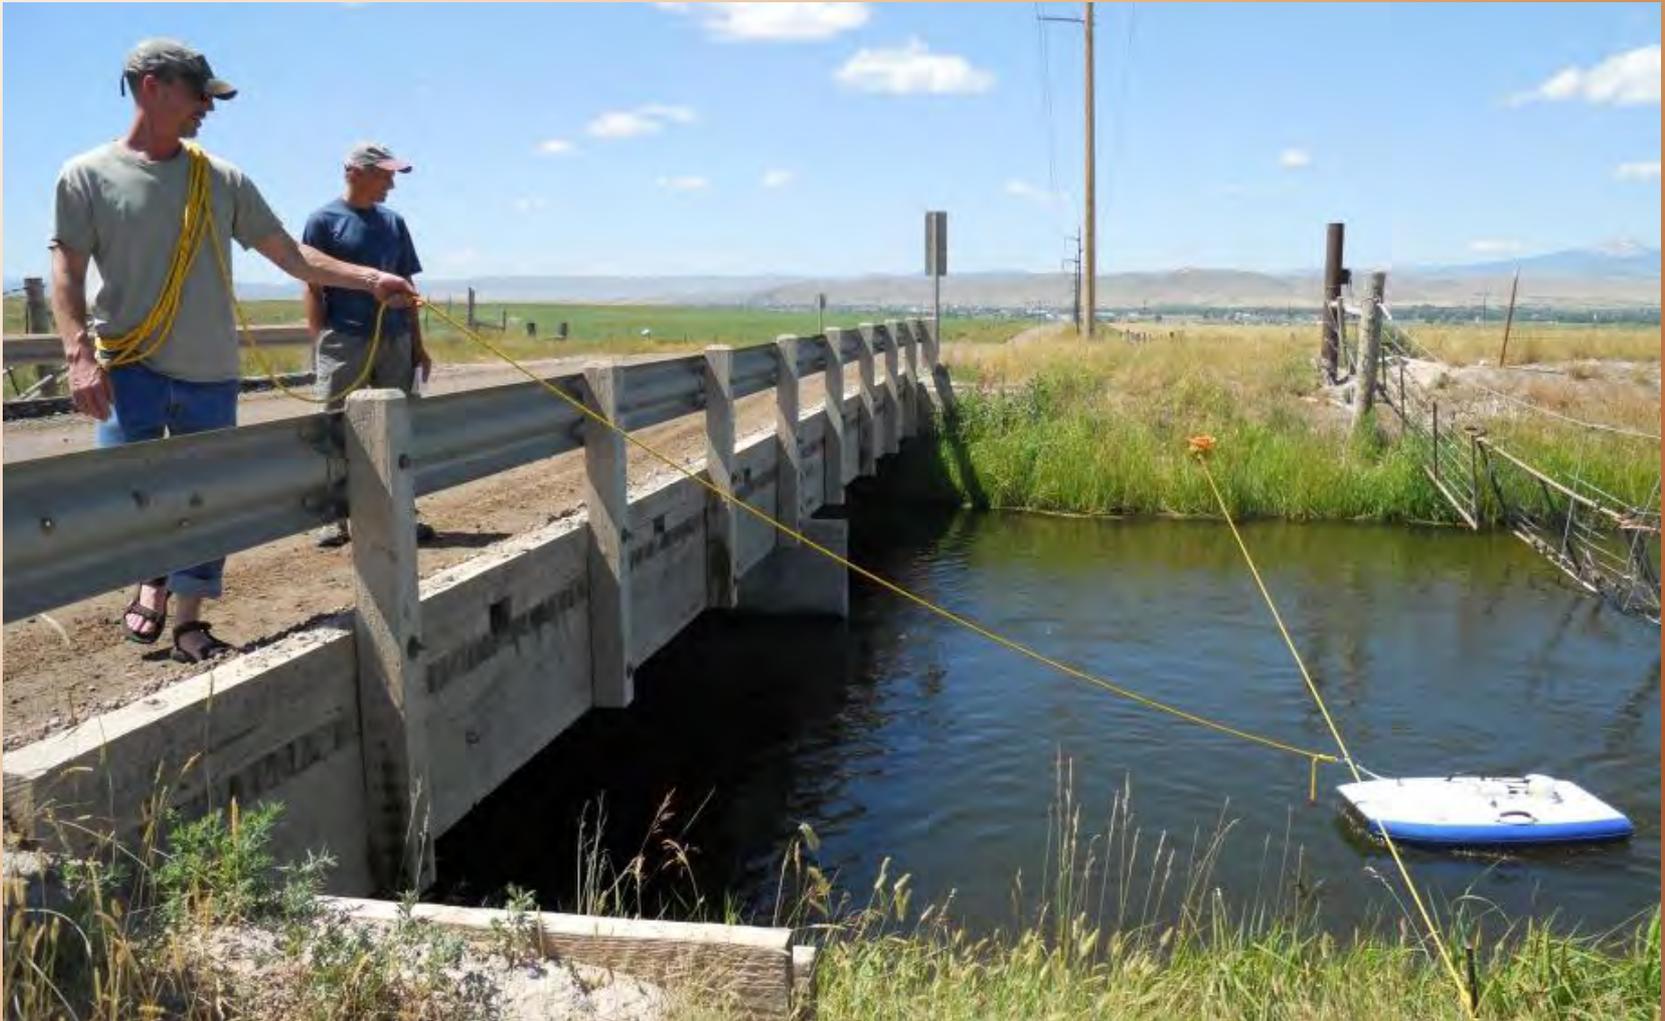
East Bench Canal Influence on groundwater

MC-1A MC-1B MC-1C MC-2 East Bench Canal

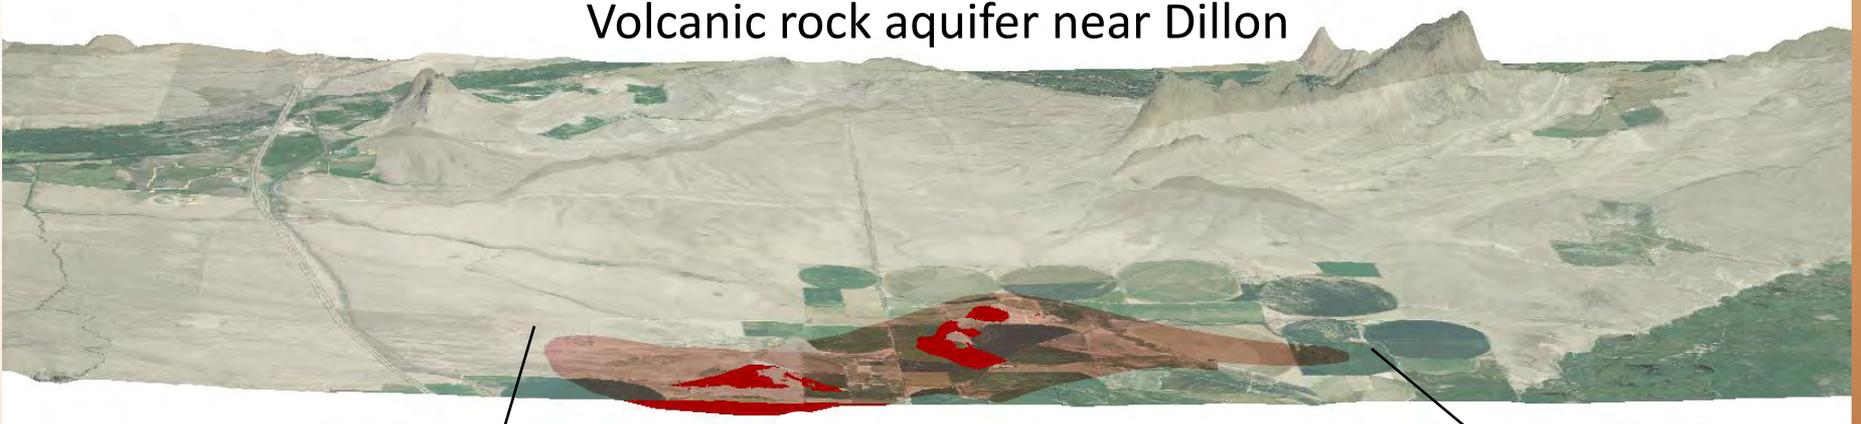
Volcanic rock aquifer near Dillon

Volcanic Rock
Pump rate 1,200 gpm
Drawdown approx. 4'

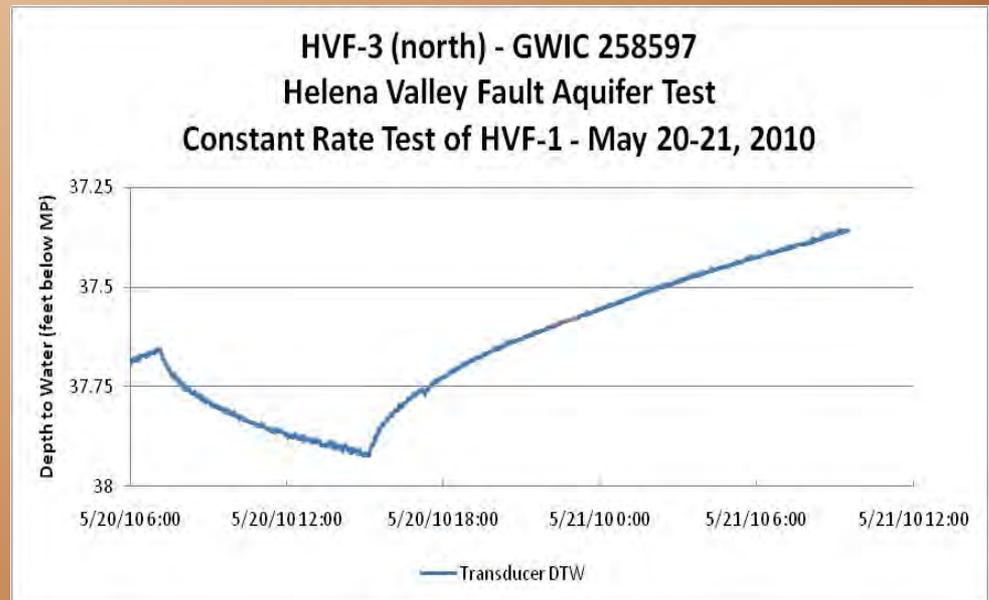
Well HVF-3
located just north of the fault zone
0.44 feet of drawdown
Little direct connection across the
fault zone

- The Helena Valley fault is a brecciated fault zone some 300 feet wide
- Clayey fault gouge acts as a boundary to groundwater flow
- The fault zone is a groundwater reservoir
- Once water is removed, in some areas it take a long time to recover
- Recharge to the North Hills area crosses the fault.
