# 2022 Statewide Facility Inventory & Condition Assessment Report

Prepared for:  
Office of Budget & Program Planning  
and Legislative Finance Committee

**MONTANA  
DEPARTMENT OF  
ADMINISTRATION**

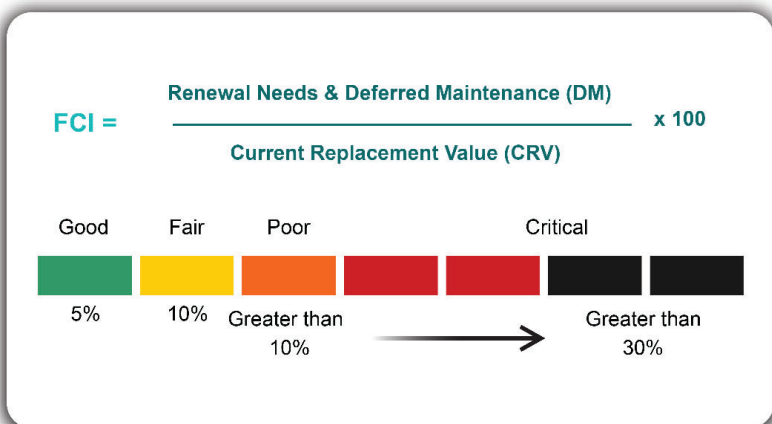
The deficiency ratio (Facility Condition Index, or FCI) is calculated by taking the total cost of existing renewal/repair costs and dividing this number by the total estimated replacement value.

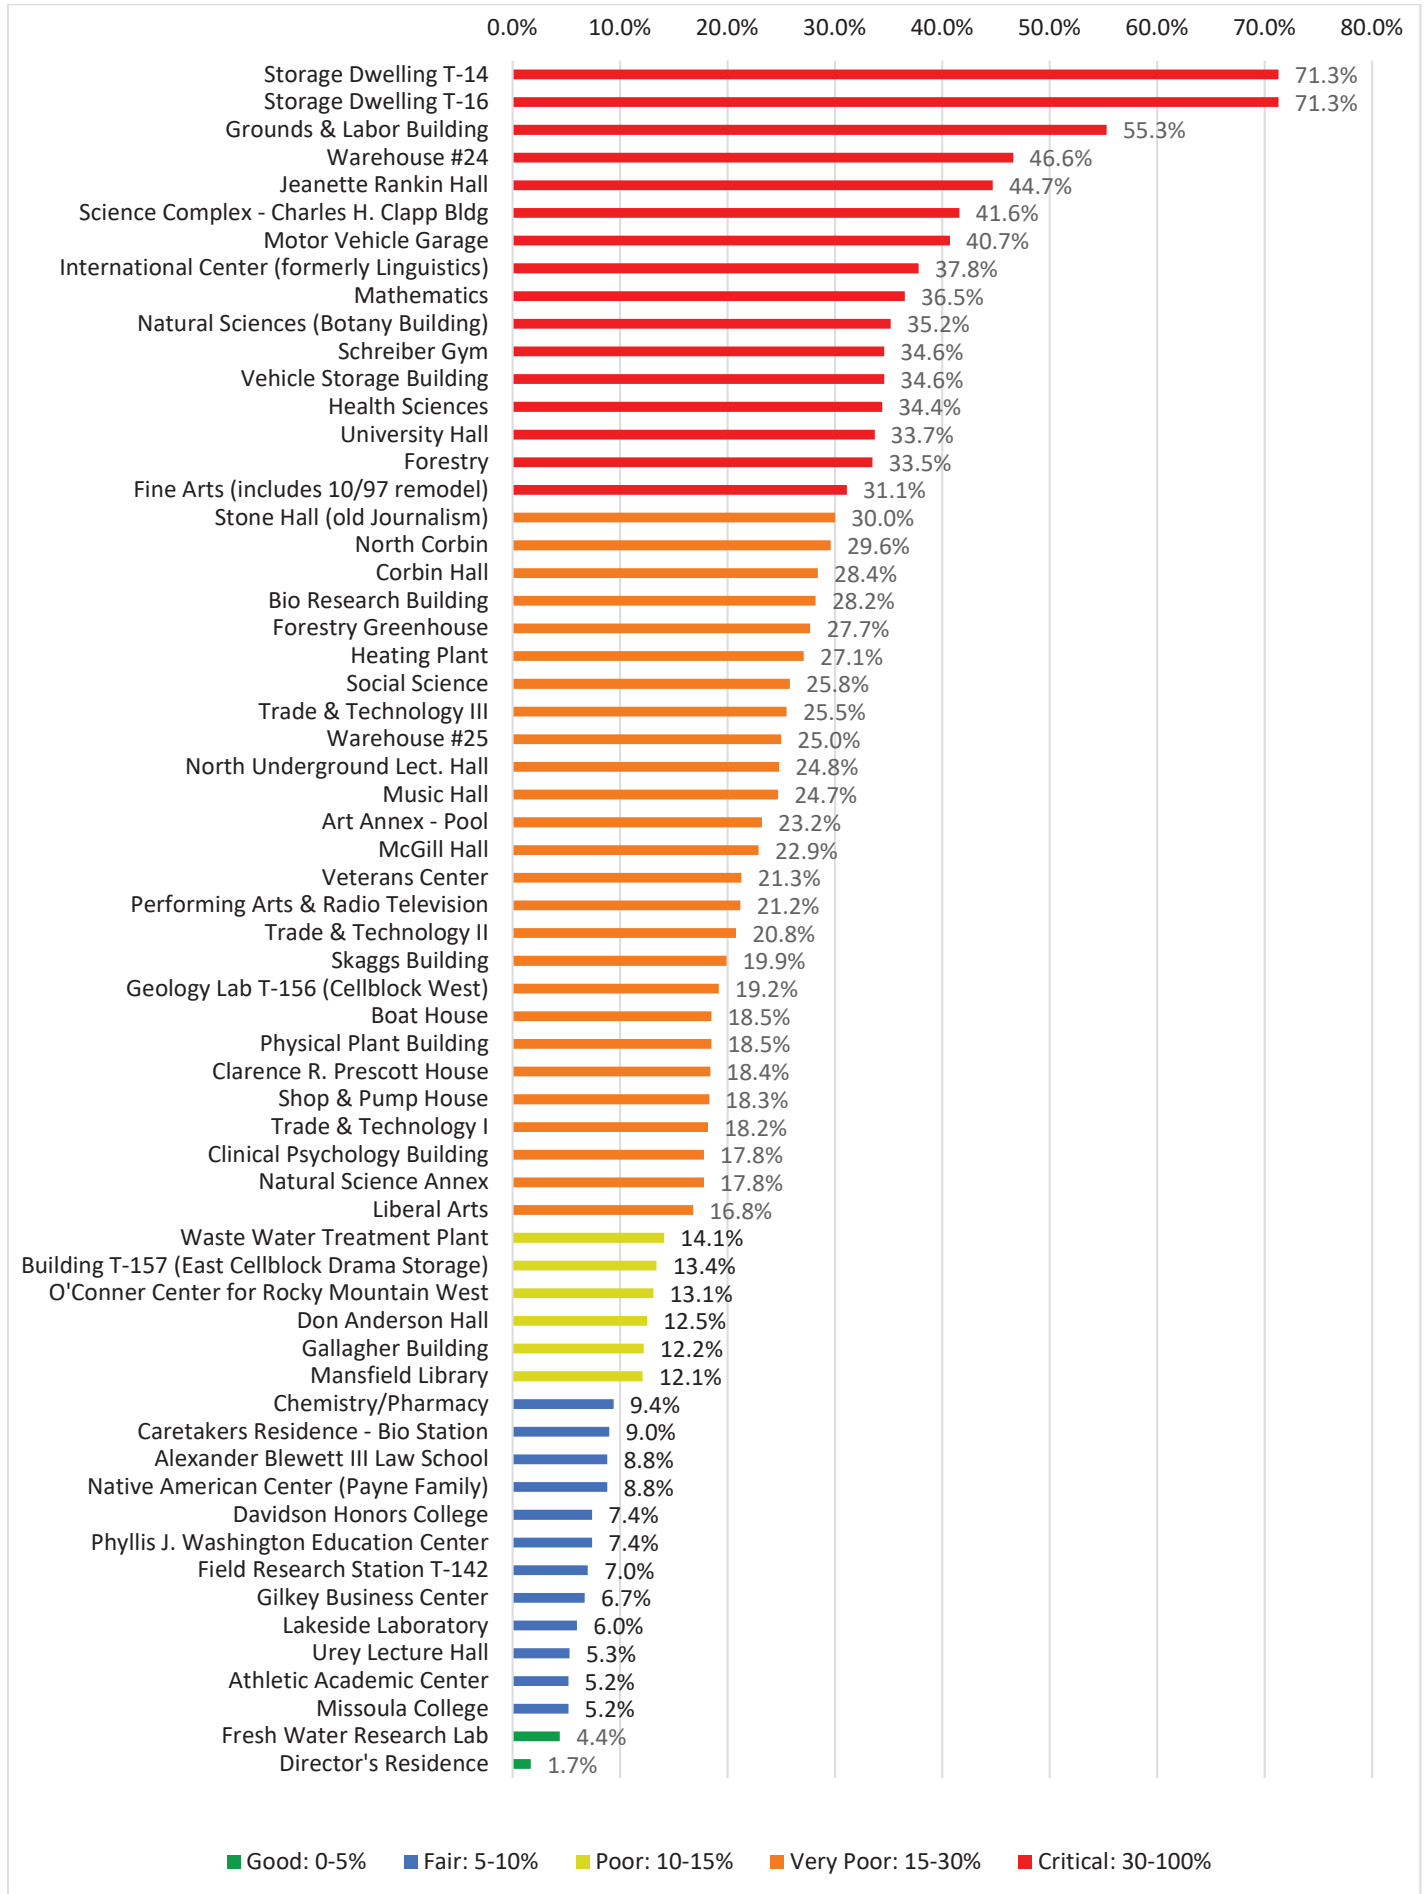
# UNIVERSITY OF MONTANA MISSOULA

## AGENCY FCI SUMMARY GRAPHS
