STATE OF MONTANA

COMBINED STATE LAB STUDY, A/E #2018-50-01

08.14.2018

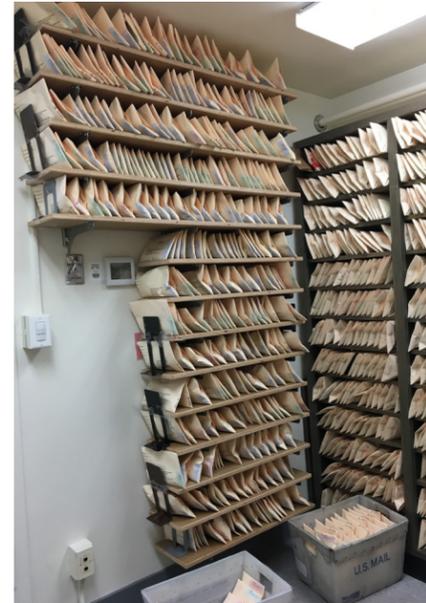
Montana Ag Experiment Station Seed Laboratory Existing Net Square Footage

The Montana Agricultural Experiment Station Seed Laboratory is also housed in Marsh Laboratory, occupying a relatively small footprint in the west wing. The organization provides seed analysis for farmers, regulatory agencies and industry groups. It also maintains a very large collection of seed samples that are intended to date back three years, but space constraints have made that policy difficult to meet. The main laboratory area for the Seed Lab received a light renovation recently and the lab operations are not particularly stringent as there is little use of hazardous materials or chemicals. The main deficiency associated with the Seed Lab is a lack of space that is the result of sharing space with the expanding operations of the Pulse Crops Laboratory. If the Pulse Crops Lab were to be relocated in the Marsh Laboratory Complex, the Seed Lab could expand into that area with little or no renovations to alleviate most of their deficiencies. The existing space allocation for the Seed Laboratory includes 1,763 net square feet. Current deficiencies in the Seed Laboratory include the following:

SPACE SUMMARY		Existing Area (Net)	
5.0	SEED LAB		
Number	Area	Room No.	NSF
5.1	Seed Lab		1,763
5.1.1	Receiving	040	94
5.1.2	Purity Laboratory	054	546
5.1.3	Dividing Room	051	105
5.1.4	Germination Laboratory	024	468
5.1.5	Germinator/Growth Chamber Room	038	169
5.1.6	Sample Storage	043, Trailer	240
5.1.7	Director Office	027	141
Subtotal - Seed Lab			1,763

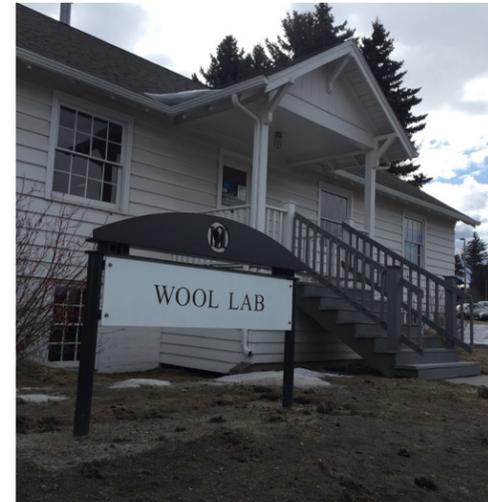
Montana Ag Experiment Station Wool Laboratory
Existing Net Square Footage

The Montana Ag Experiment Station Wool Laboratory is in a stand-alone historical building located at a major vehicular entrance on the north side of the Montana State University campus at the intersection of Harrison Street and 11th Avenue. The building was constructed in 1947 and is a two story, wood framed structure with a walk-out basement, storage attic and a large garage area in the rear. It is one of only two facilities in the country that provide wool fiber and fleece analysis to aid breeders in the selection of genetic traits, and the operation shares a long and significant history with Montana State University. There are two major services provided by the Wool Lab that are difficult to accommodate in the historic structure. One of their most important analytical tools is the Optical Fiber Diameter Analyzer. This instrument should be located in a controlled laboratory environment where temperature and humidity can be reliably controlled, but no such space exists in the current facility. Another routine procedure involves boiling fleece samples in chemicals for which the existing exhaust system is not suitable. If the Wool Lab is to remain in the historic structure, certain spaces should be upgraded to accommodate these needs. Periodic national meetings and conferences involving breeders are also held in the Wool Lab and have become difficult to accommodate as the number of attendees has grown. Truck access is also a challenge on the existing site. The overall space and size of the facility is large enough to accommodate their needs now and into the future. The building is comprised of approximately 4,781 net square feet. Current deficiencies in the Wool Laboratory include the following:

SPACE SUMMARY		Existing Area (Net)	
2.0	WOOL LAB		
Number	Area	Room No.	NSF
2.1	Wool Lab		4,781
2.1.1	Receiving Garage & Sample Storage	008, 010	1,563
2.1.2	Analytical Laboratory	102	292
2.1.3	Wet Chemistry Laboratory	001, 003, 004	1,090
2.1.4	45-Person Classroom	101	458
2.1.5	Director Office	107	157
2.1.6	Open Office	108	238
2.1.7	Storage	002, 103, 105, Attic	825
2.1.8	Vacated Office	106	158
Subtotal - Wool Lab			4,781

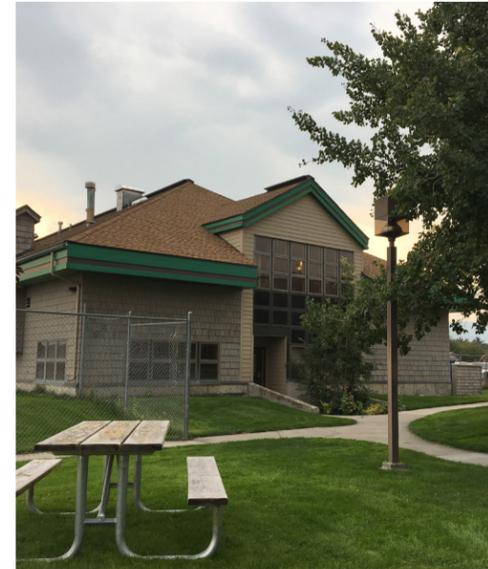
**Fish, Wildlife & Parks - Wildlife Laboratory
Existing Net Square Footage**

The Fish Wildlife and Parks Wildlife Laboratory is located in on the east side of 19th Avenue across from Marsh Laboratory on the site of the FWP Region 3 headquarters. Situated in a stand-alone structure to the east of the main building, the Wildlife Lab consists of a main necropsy space with a small wet laboratory and walk-in cooler / freezer space. The facility was undergoing a minor renovation at the time the initial discovery phase of this study began. The renovation has created the small wet lab space with a new chemical fume hood, improved the ventilation and made provision to add an overhead monorail system for the necropsy floor. The renovation also added a small storage room to accommodate a mobile x-ray unit that is often used in forensic investigation. The facility is not equipped with a means to dispose of carcasses so the Wildlife Lab is required to transport it's large animal waste across 19th Avenue to the incinerator at the VDL. This represents both a deficiency in both efficiency and biosecurity. Users of the Wildlife Lab, however, have stated that it is advantageous to be co-located with the FWP Region 3 for the purpose of increased interaction with field personnel and game wardens.

SPACE SUMMARY		Existing Area (Net)	
3.0	FWP WILDLIFE LAB		
Number	Area	Room No.	NSF
3.1	FWP Wildlife Lab		2,992
3.1.1	Reception & Open Office		470
3.1.2	Director Office		90
3.1.3	Staff Office		272
3.1.8	Lockers, Shower, Gowning & Boot Room		280
3.1.9	Sample Prep		221
3.1.10	Necropsy		400
3.1.11	Holding Cooler		135
3.1.12	Holding Freezer		80
3.1.14	Laundry & Equipment Room		97
3.1.15	Laboratory Storage		565
3.1.16	Garage		382
Subtotal - FWP Wildlife Lab			2,992

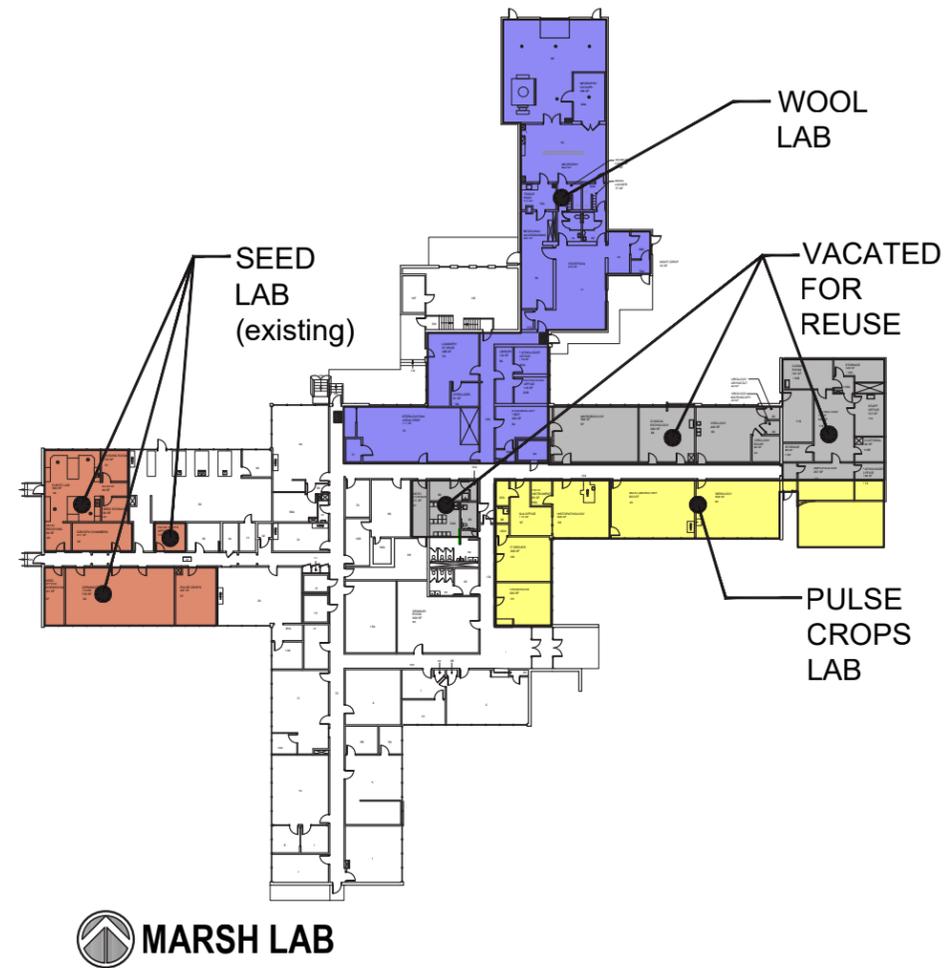
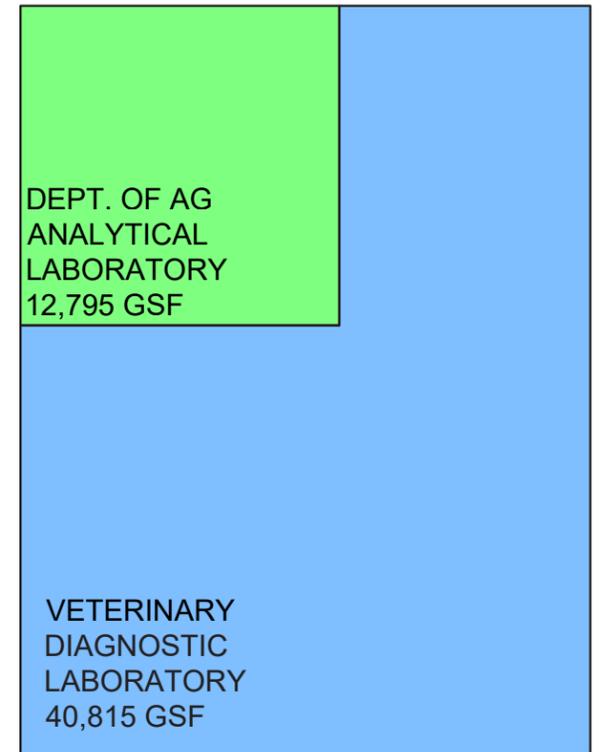
OPTION 1 FEATURES
 Veterinary Diagnostic Laboratory and Dept. of Ag Analytical Lab in New Building
 Wool Lab and Pulse Crops Lab in newly renovated space in Marsh Lab Complex
 Seed Lab expands into adjacent unrenovated space in Marsh Lab Complex
 FWP Wildlife Lab remains in present location
 10,500 net SF of space vacated for reuse in Marsh Lab Complex and McCall Hall
 Project Cost - \$37,985,471

The complete tabulation of all spaces, square footages, estimated costs per gross square foot and estimated soft costs for Option 1 (excluding site work and utilities) is shown on the following pages. The costs for new construction have been escalated to a mid-point of construction in the Winter of 2021. The costs for renovation in the Marsh Complex have been escalated to a mid-point of construction in the Winter of 2022 due to the fact that renovations in the Marsh Complex cannot commence until the Veterinary Diagnostic Laboratory has vacated the space. The total project cost for Option 1 is estimated to be approximately \$37,985,000.

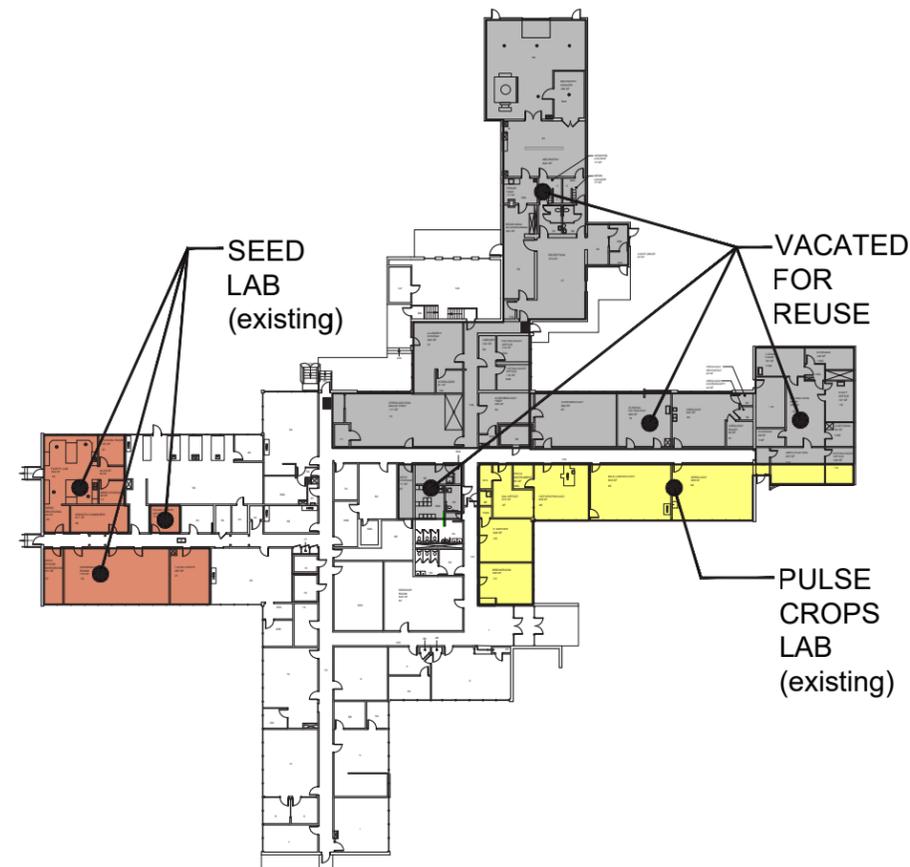
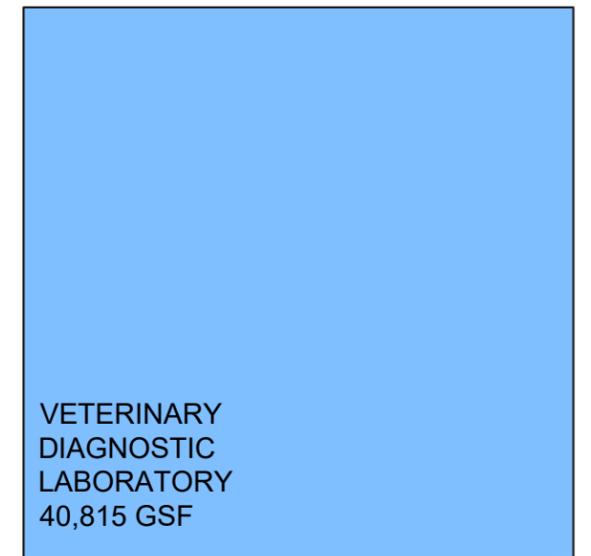
OPTION 3 FEATURES
 Veterinary Diagnostic Laboratory in New Building
 Pulse Crops Lab expands into unrenovated space in Marsh Lab Complex
 Seed Lab expands into adjacent unrenovated space in Marsh Lab Complex
 Dept. of Ag. Analytical Lab, Wool Lab and FWP Lab remain in present locations
 8,600 net SF of space vacated for reuse in Marsh Lab Complex
 Project Cost - \$26,028,977

The complete tabulation of all spaces, square footages, estimated costs per gross square foot and estimated soft costs for Option 3 (excluding site work and utilities) is shown on the following pages. The costs for new construction have been escalated to a mid-point of construction in the Winter of 2021. The total project cost for Option 3 is estimated to be approximately \$26,028,977.
